Research Article

The Collapse of Wooden Roofs of Public Buildings in Macedonia Caused by Winds

Sulejman Meta^{†*} and Shinasi Zendeli[‡]

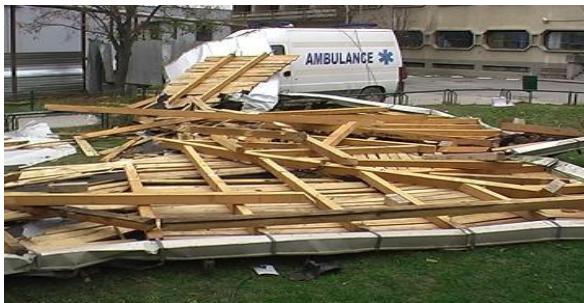
schools: in elementary schools in Trapcin-Dol near Kicevo, in Ohrid, in the village of Debarce and in the village Bogovinje near Tetovo, as well as at the gymnasium in Tetovo. When a roof fell from a hospital building in Tetovo, one person was killed and serious injuries were caused to several people. Considerable material damage was done. The roof construction of the hospital in Tetovo was previously reconstructed twice; however, it collapsed under the influence of the wind (Figure 2). In January 2012, the roof of the school in the village of Debarce near Tetovo collapsed.

Fig. 2 The roof of the hospital in Tetovo

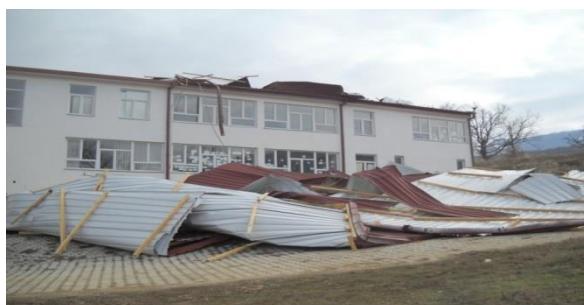
Fig. 3 School in Debarac-Tetovo

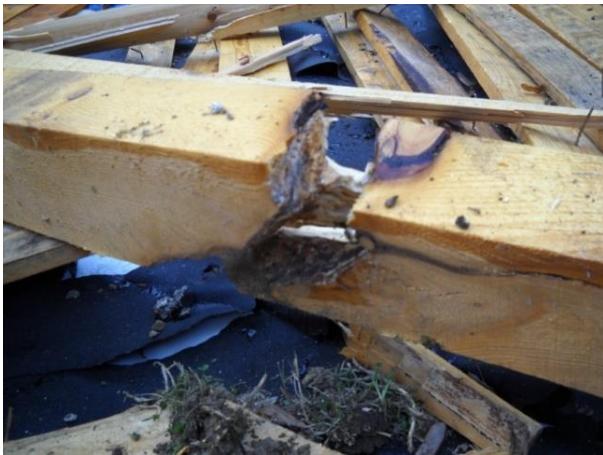
Fig 4. Non-standard timber

The material used for roof structures was, above all, not in accordance with standards, and had many defects such as: bumps larger than 1/3 of the cross-section and crossing the whole cross-section of the beam; Rot and color of wood; Insect damage (Figure 4); Bugs in construction, unmanaged finishes; Irregularity and sharpening of fibers; Untended core and bark of wood as well as many other defects of wood. In almost all elements of the construction, several errors have been detected on the supporting elements, such as beams, columns and on planks below the sheets.

- 4) Wooden materials used for building roofs should be pre-arranged examined, in particular her health condition as well as class quality.
- 5) Conduct control of other roof structures that collapsed, as in the future, or there would be disasters and threats to people and material goods.

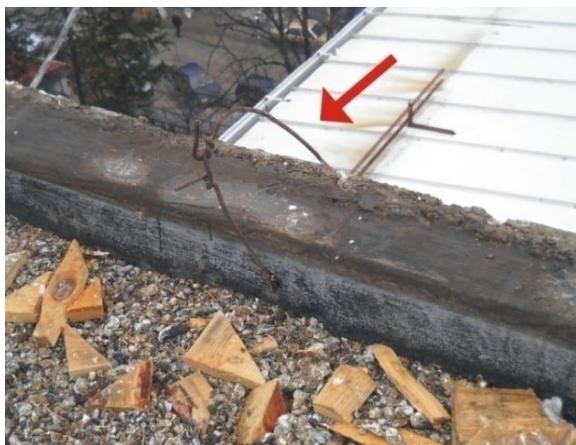
Fig 5. Enforcing the wreath of the roof with armature

bonding with thin reinforcement or cracked pins and concrete (Figures 5 and 7), where the connection was loose, which enabled the movement of the roof structure in the wind, and then demolition. In Figures 5 and 7, there is an unqualified design after the completion of the installation of roof structures, as no surpluses and waste of materials such as woodcuts, pieces of metal sheet, wire, silicone bottles, nails and others have been removed.

- 2) The Commission for Technical Inspection should be competing. Construction control it should be permanent, at all stages of construction.
- 3) Pay particular attention to anchoring the base of the roof structure for armor-concrete supports, stop with the current practice of wire and armature bonding, which proved inadequate. The basics of roofs must be fixed with special anchors that must be attested and meet the standards.

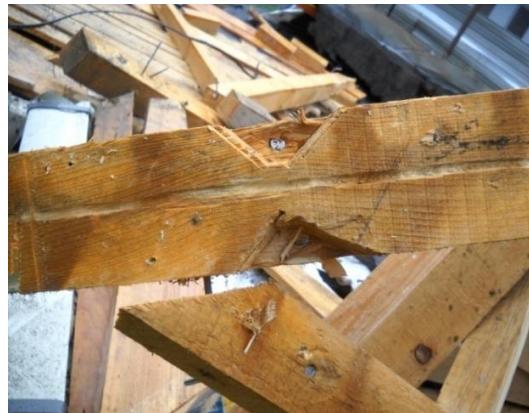
All carpentry works were performed using a primitive tool, the requirements for the geometry of the carpentry connections were not respected; only nails were used as connecting means in insufficient quantities.

Fig.6 Coarse bonding without geometry

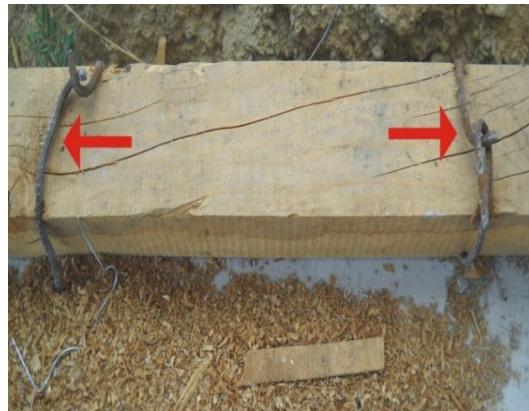
Fig. 7 Inadequate armor anchoring
