Research Article

The Quality of Wooden Railway Lines in North Macedonia and Kosovo

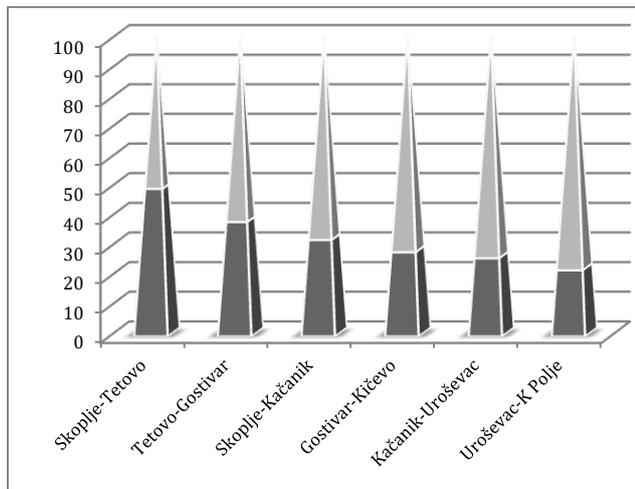
Fig.1. Overview of the loss of mass of wooden tracks

- 1) Skopje-Tetovo 49%;
- 2) Tetovo-Gostivar 38%;
- 3) Skopje-Kačanik 32%;
- 4) Gostivar-Kičevo 28%;
- 5) Kačanik-Uroševac 26% i
- 6) Uroševac-Kosovo Polje 22%.

From the results obtained, it is clear that the greatest decrease in quality of the tracks was recorded on the Skopje-Tetovo section, while the lowest on the Uroševac-Kosovo Polje section. If the abovementioned routes are observed, it is clear that there is a greater decrease in quality of the tracks on the Skopje-Kičevo route, and the average decrease percentage is 38.3%, while the quality decrease is 26.6% on the Skopje-Kosovo Polje route. The reasons for this kind of different decrease in quality are most likely due to different climatic conditions (temperature differences, precipitation), usage patterns and load on the railway connections, the manner of periodical and permanent maintenance, as well as other factors.

Having in mind the results from the research that showed that there is a significant decrease in quality of the rail sleepers, in particular on the section Skopje-Tetovo, Tetovo-Gostivar and Skopje-Kačanik, where a decrease of more than 30% was observed, it can be concluded that special measures need to be taken and a complete reconstruction should be done, that is, to replace all wooden rail sleepers due to deterioration.
