# Effect of Heat Treatment on Mechanical Properties and Microstructure of ST 37-2 Rear Trailing Arm (Case study at MIE)

Ashish Thakur<sup>1\*</sup> and Gebre-egziabher Aregawi<sup>2</sup>

*This paper presents effect of heat treatment (annealed, quench hardened, and tempered) on mechanical properties and microstructure of the rear trailing arm case study at Mesfin Industrial Engineering PLC, Ethiopia. The samples were heat treated in muffle furnace in Mekelle University, Heat Treatment Lab at different temperature levels and holding times; and then cooled in different media. The mechanical properties (tensile yield strength, ultimate tensile strength, percentage reduction, and percentage elongation), bending, impact and hardness of the treated and untreated samples were determined using standard methods and the microstructure of the samples was examined using metallographic microscope equipped with camera. Results showed that the mechanical properties of ST 37-2 steel can be improved by various heat treatments for a particular application. The micrograph revealed that the microstructure of tempered specimen consisted of a number of appreciable carbide particles precipitated out fr

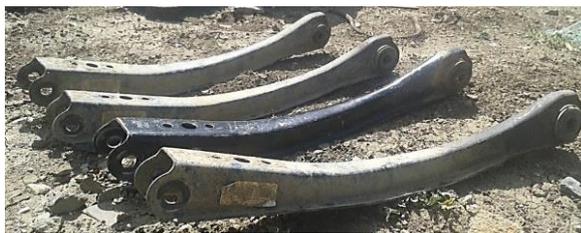
**Fig.1.** The existing damaged rear trailing arm

However, its customers are not fully happy due to the failure of some parts. It has been observed that the rear trailing arm fails repeatedly and customers always claim at the company this problem. Among the parts of suspension system which fails repeatedly is the rear trailing arm. It fails due to excessive deformation that tends to be straightened. As a result, the tyre wears quickly due to camber effect. The remedial action which the maintenance personnel always take is only replacing the part by another new one.

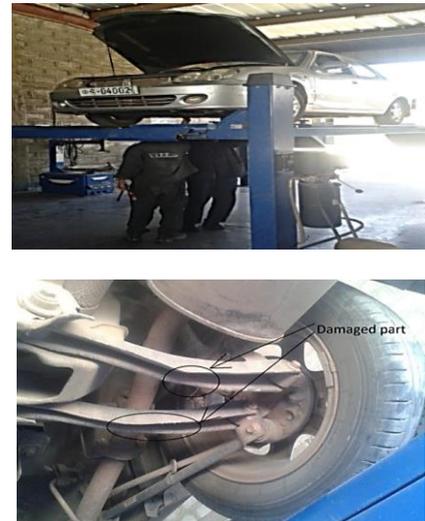
**Fig. 2.** Damaged trailing arm under maintenance

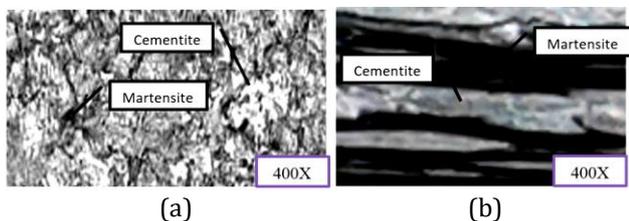
**Fig. 16.** Microstructure of non-heat treated specimens (a) existing rear trailing arm after tensile testing (b) existing rear trailing arm after impact testing

Microstructure observed for non-heat treated specimen at 400X and it was observed from Fig. 16 given above that there is a fusion of cementite and martensite zone in the INSET of image in the case of Trailing arm after tensile test. It was also observed that the cementite and martensite zone as the bay type fusion zone at 450 degree tempered microstructure image taken at 400X in case of specimen after impact testing.

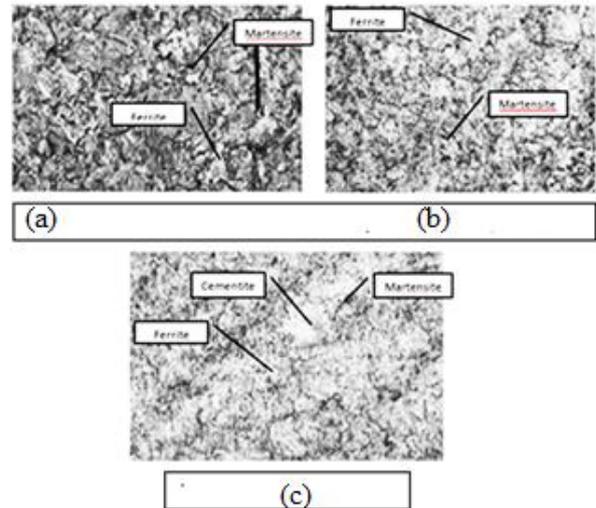
Microstructure of heat treated tensile specimens picked at 250°C, 450°C and 650°C were taken at 400X using the optical microscopes shown in Fig. 17 given below. It is observed that carbon particle is like a stain in the middle part of the inset surface while cementite of little variation can be found in the whole surface in segregating but carbide in the form of ferrite but percentage is high at 250°C while in cementite a little higher in comparison to 450°C. Little martensitic is also observed at 450°C when it is compared to 650°C. It is observed that particles are distorted and distributed of the bulk cementite is higher in comparison to 250°C and 650°C. Recrystallization is no more, however brittleness is shown at 650°C and at hence strength is less. Microstructure of heat treated impact testing specimen at those three tempered specimens are shown in Fig. 18 given below.

**Fig. 17.** Microstructure after tensile testing (a) 250°C (b)450°C and (c) 650°C

A tensile and impact test specimens were observed under optical microscope and it was informed that there is almost equal distribution of ferrite and pearlite. This implies that failure might have occurred due to ductile failure. The reason is that the dusty ferrite and impact crystals are broken in percentage and stress is relieved at high load. Recrystallization was not observed any more, however brittleness is shown at 650°C after tensile testing. It is observed from that at

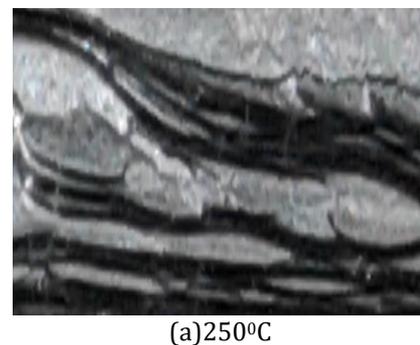
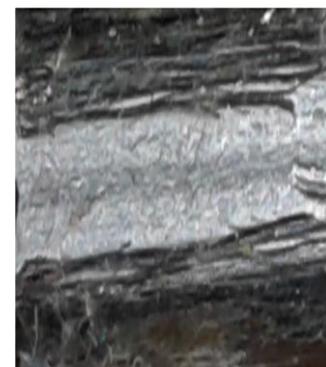
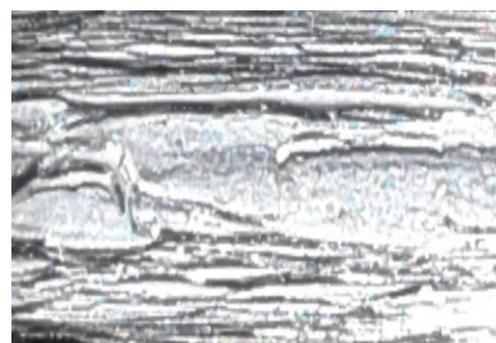
**Fig. 18.** Microstructure of heat treated after the impact testing

450°C is a less cleavage is there in comparison to 250°C and it clearly seems that brittle fracture occurred after impact tests.

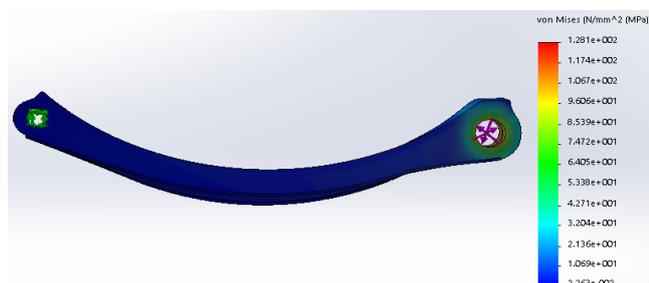
The von mises stress observed for 3G load condition of the Rear Trailing Arm is 128.1MPa for St-37, which lies within the yield limit of the material. Von Mises Stress for modified design of Rear Trailing Arm is shown in Fig. 19 given below. Hence the design is safe. Fatigue analysis was also carried out for the tempered modified design of Rear Trailing Arm. Deformation for the modified design Rear Trailing Arm graph is shown in Fig. 20. Damage percentage of Rear Trailing Arm (a) existing (b) heat treated samples is shown in Fig. 21 given below. Static stress analysis result for St-37 Rear Trailing Arm is shown in Table 7.

**Fig. 19.** Von Mises Stress for modified design of Rear Trailing Arm

In the modified design model, the thickness and material property was improved by changing 2mm to 5mm of St-37 material quality. Static structural analysis is carried out for the modified design under 3G bump load condition for each material types.

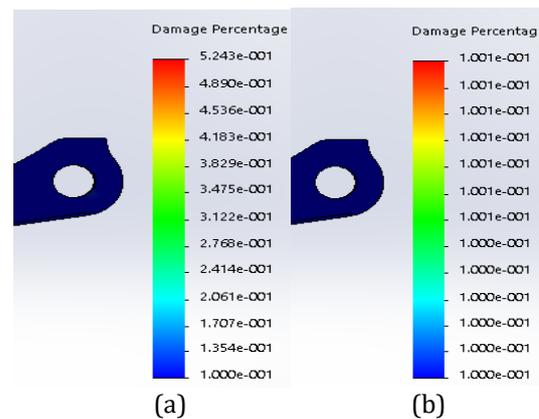
**Fig. 21.** Damage percentage of Rear Trailing Arm (a) existing (b) heat treated

The damage plot shows the percentage of the existing Rear Trailing Arm's life consumed by the specific fatigue event. The fatigue event consumes 0.52 %, while modified heat treated Arm's life consumed by the specific fatigue event is only 0.1 %. The new modified design is statically and dynamically safe. The modified heat treated rear trailing arm has been observed safe with factor of safety 1.83 and 0.73 static and dynamic respectively.
