# Failure Analysis of a Center Bearing Bracket Mount of a Propeller Shaft in BS-II Buses

Accepted 06 March 2015, Available online 18 March 2015, Vol.5, No.2 (April 2015)

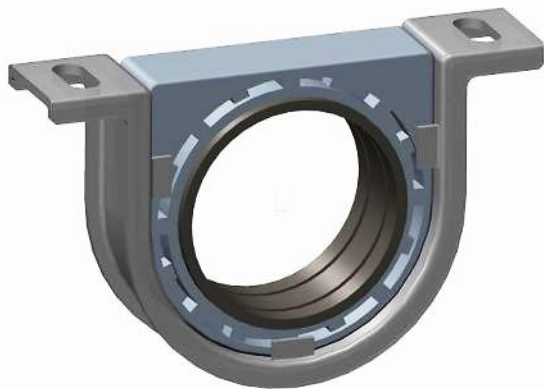
**Fig.2** Center Bearing Bracket Assembly

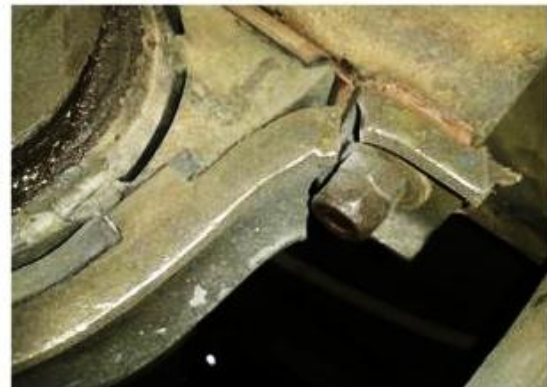
Fig.9 crack at the fillet region in working condition

In the figures (9&10) shown above the center bearing bracket failed at the junction of bracket flat end and semicircular end. It means that the stress concentration is more at the fillet radius. Similarly in the finite element analysis, the maximum stress is observed at the fillet radius as shown in fig (7). The stress observed at the fillet radius is 830.49 MPa which is very high. The load applied on the Center Bearing Bracket is estimated using the fatigue strength of the bracket by assuming the endurance limit as 0.5. The estimated load calculations are presented below.

To overcome this bracket failure, the bracket is redesigned and finite element analysis is carried out for 6mm, 7mm, 8mm, and 9mm thicknesses.

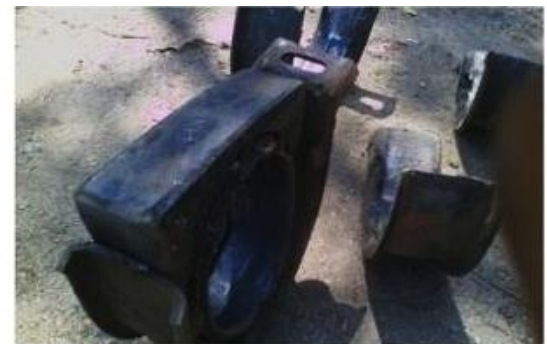
Fig.10 Figure showing some failed regions
