Research Article

Wood Lamella Parquet Recovery-Caused by Attack of the Insects

*In the last few decades lamella parquet (which is made of solid wood) has been used for interior house flooring and commercial buildings in Macedonia. The poor structural protection or not placing the parquet very well can create several conditions for developing wood pests that can lead to attacking the floor surface and of course causing problems. The floor surface can be destroyed due to the attacks of insects that can lead to big economic losses. The first part of this paper refers to the floor attacks caused by the insects called *Bostrychus capucinus* L, as well as the damages caused to the buildings. In the second part an overview for recovery is given, as well as methods and techniques that can be used. Also economic parameters that can influence taking actions for recovery are analyzed.*

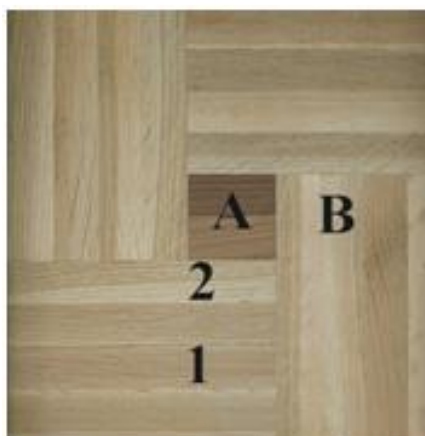
Picture 1: cube | lamellar parquet – mosaic parquet

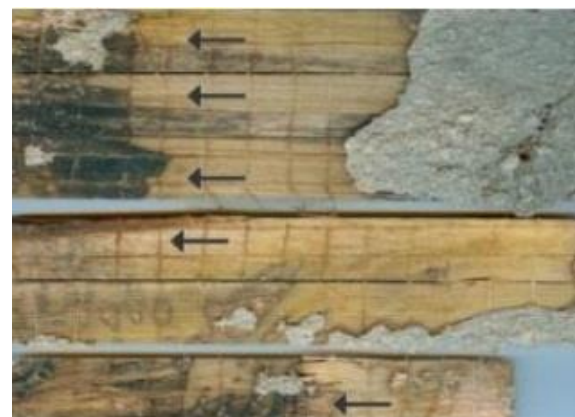
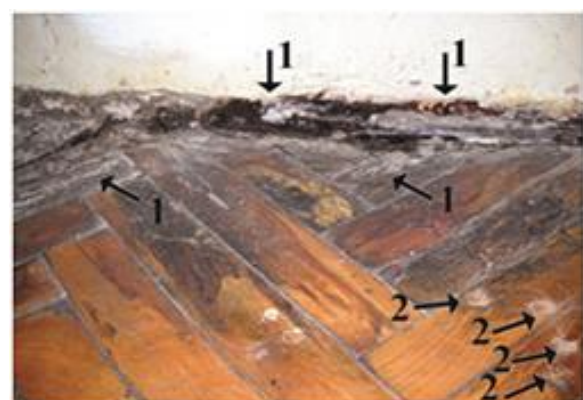
Picture 2: Attacked LAMELLAR (up) and solid parquet (down) by fungi and insects

In case of many objects on which laminated flooring was installed, fungus attack happened as a result of permanent or alternate wetting with water. Wetting parquet primarily occurs next to sanitary facilities

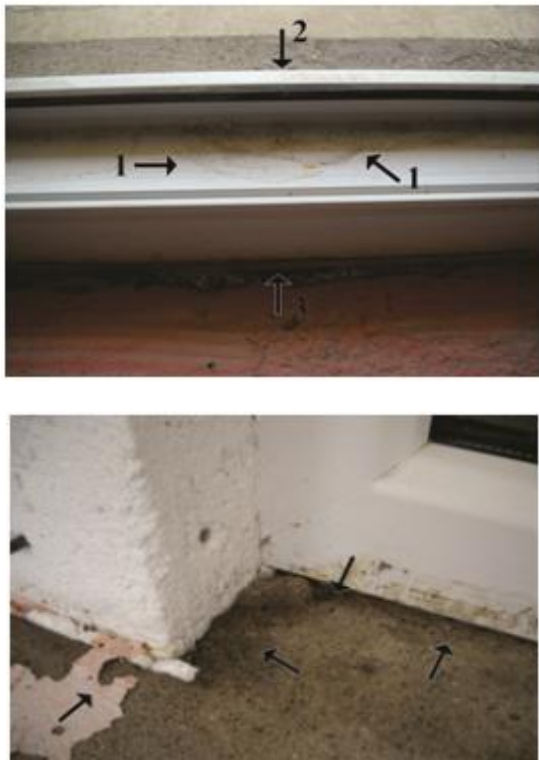
(bathrooms, kitchen) and in places where water breaks through the windows and external doors (Pic. 2, 3)

Picture 3: Wetting of the interior spaces through the door (up) and the look of the cement cover under the removed parquet (down)

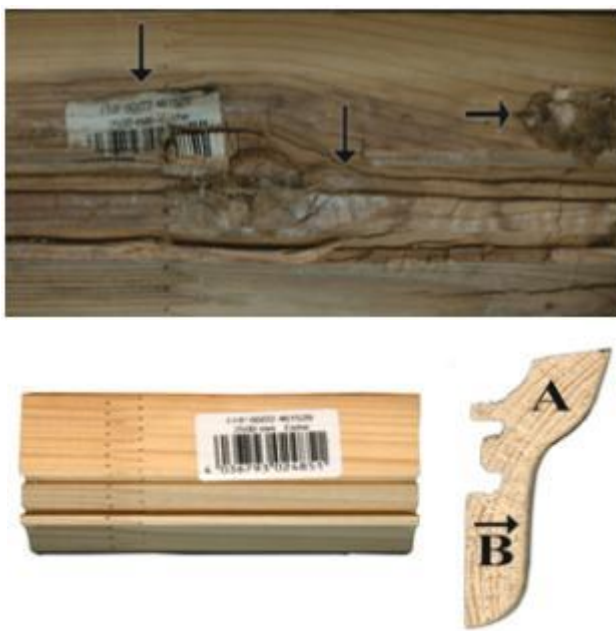
Wetting the most distant parts primarily leads to wetting the cover of the planks, which first begin to rot and become target of attacks by insects (Pic. 4).

Picture 4: Attacked batten (up) and healthy batten (down)

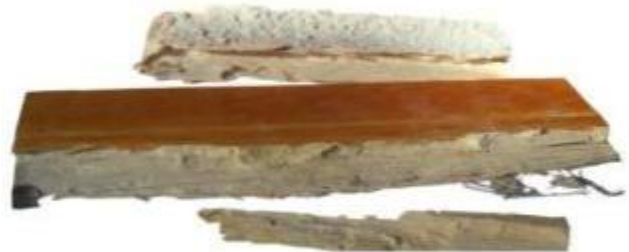
In many residential buildings, there was an attack by insects, primarily by **Bostrychus capucinus** L., which caused major damage. During the research, it was not possible to establish the real reasons for the emergence, and spread of the attack. The appearance and intensity of the attacks for the mentioned insect can be seen in Picture 5.

Picture 5: Parquet planks damaged by insects

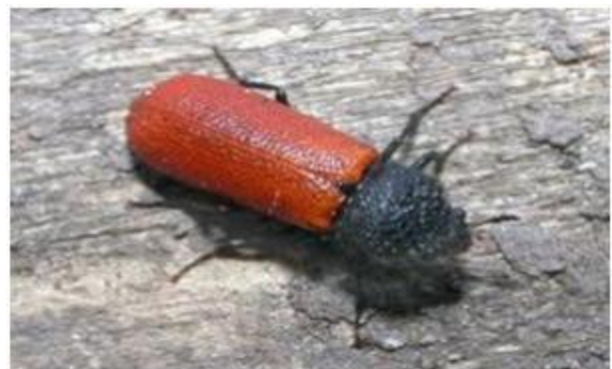
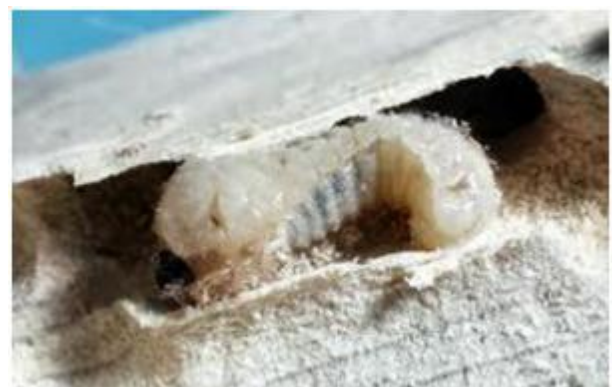
The insect **Bostrychus capucinus** L., which was the cause of the attack on the lamella parquet flooring made of oak. This insect is 8-14 mm long. His body is black and red cover (Pic.6).

Picture 6: The look of the insect *Bostrychus capucinus* (up) and fungus (down)

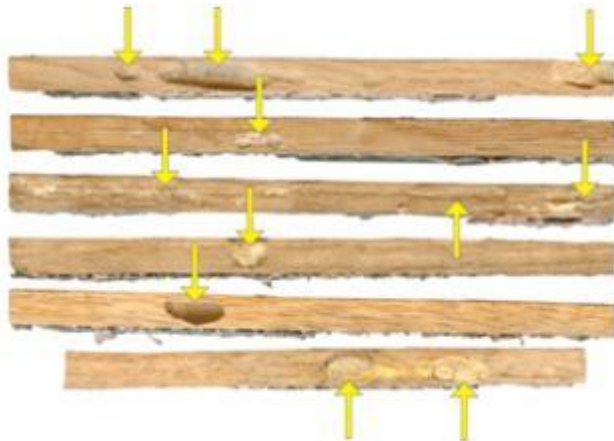
Picture 7: Attack on the lamella parquet flooring by insects

The attacks that occurred on the LAMELLA parquet clearly indicate that the start of the insect development of the eggs began on the parquet plates at the joints. This can be seen in Picture 7. It is indicative that there is a probability that the insect laid eggs in the holes that are created while placing the LAMELLA parquet. Picture 8:

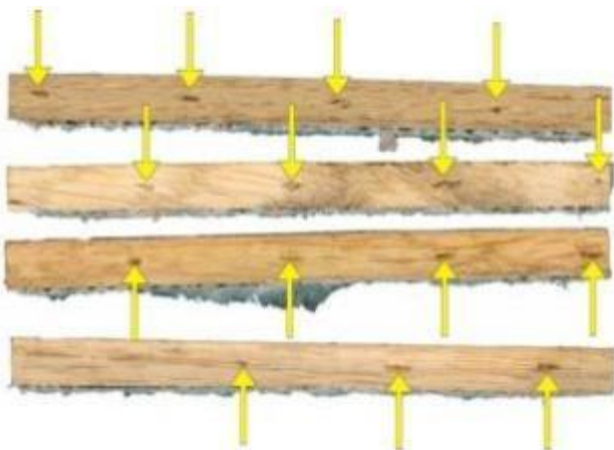
Picture 8: Holes created during the production of the parquet

The central part of the flooring that has been attacked was made of wood with a darker color to get the aesthetic effect of the same wood, so it can be assumed that the attack might come just from these small planks. Despite the fact that the parquet strips were thermally processed, it was not possible to determine whether the material in the central part of the flooring was exposed to heat treatment. In Picture 9 on the left, there is a section marked by arrows corridors with compacted wormhole, and on the right side of the picture, you can see the holes made by the insects.

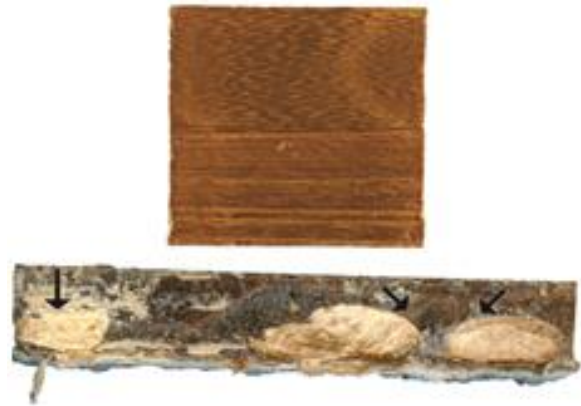
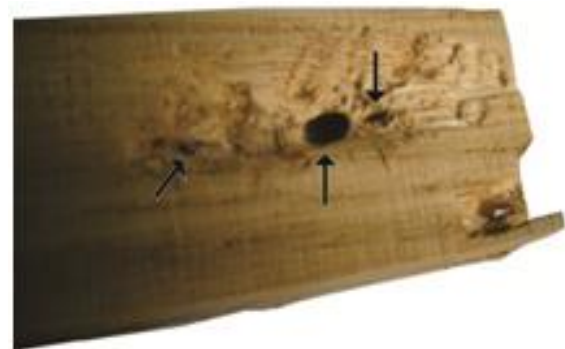
Bostrychus capucinus swarms in May and June, after 2 to 3 weeks the cocoon are coming out, they can spend several days not eating, and then they crawl into the real wood and corridors to 0.5 cm in diameter (Pic. 5, 7, 9-right).

Picture 9: Central part of the wood, attack of the Insects up, and holes-down

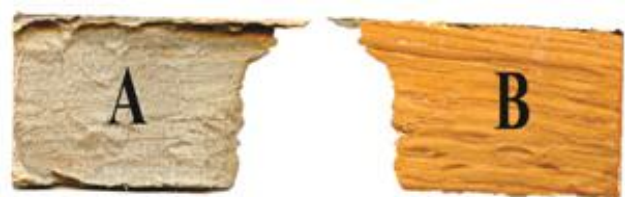
The development could last one year. The dimensions of the hall fit the insect, which can lead to destruction of LAMELLA parquet. The thickness of the parquet flooring while placing is 8 mm, after sanding the same floor gets thinner for about 1 mm, so that the new thickness is about 7 mm, the real insect corridors are about 5 mm in diameter. Since the insect uses LAMELLA parquet flooring for food and accommodation, it does not come to the surface. Also the insect cannot go in the opposite direction because it faces with the adhesive and concrete, so he leaves at about 1 mm, of healthy wood (Official. 10). The attacks on the wood are very difficult to be traced, so it leads to difficulties in determining the steps to recovery because they cannot accurately determine the areas of the room where the parquet has been attacked and replace the flooring.

Picture 10: Thin layer of lacquered parquet flooring, A- inner, B-outer lacquered part

The recovery of the flooring must be carried out by detailed control that is performed on the entire surface. Reparation is done when there is a large flooring damage due to some external influences. The first approach is eliminating the causes of damage, and then removing the destroyed parquet. When all the damaged flooring is taken out, the process of grinding and coating starts. During the floor recovery anti-insecticide and anti-fungal protection should be applied. Despite the recovery and treatments, it happens that a small number of insects survive the treatment. For these reasons, it is best to remove the entire parquet, burn it and then place new parquet flooring. This approach is justified because of the low price of the LAMELLA flooring, which is several times cheaper than the conventional one. On the right in Picture 10, excavated LAMELLA parquet flooring that was later burned can be seen.

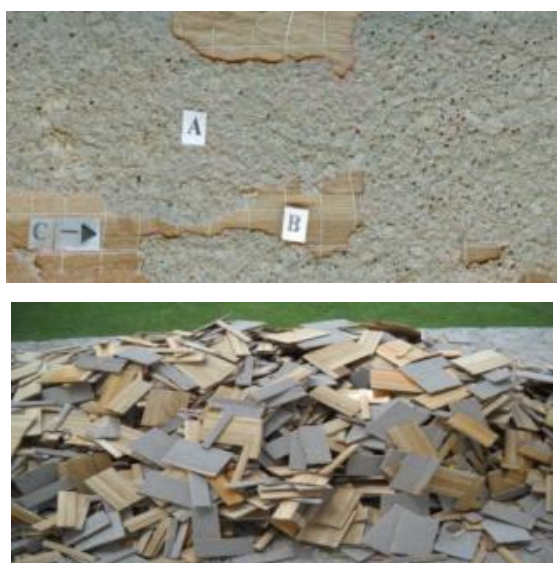
Picture 11: The bottom of the removed part of the parquet (up) and removed lamella parquet attacked by insects (down)

In cases where attack on LAMELLA parquet by insects happened, the first thing should be done is making proper assessment of the actions for recovery. Sometimes in practice the recovery did not give the best results and the attacks by insects appeared later again. Because of the relatively low price, the repressive method of removing the whole LAMELLA parquet and replacing it is the most economical one.
