# Fatigue Behavior and Fracture Mechanism of a Hot Rolled AA7020 Aluminum Alloy

Ashish Thakur\*

Department of Mechanical Engineering, Solid Mechanics and Design Chair, Ethiopian Institute of Technology, Mekelle University, Mekelle, Ethiopia

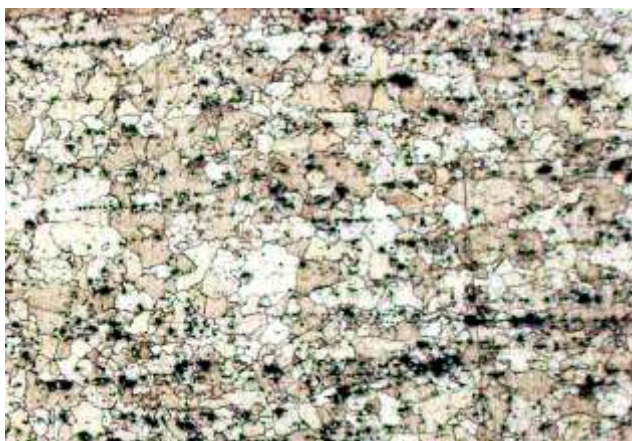
Figure 1 shows the microstructure of the alloy, which consisted of equiaxed grains and macroscopic anisotropy of the microstructure is not recognized. The average grain size is approximately 40-80  $\mu\text{m}$ . The mechanical properties in the longitudinal rolling direction are 0.2% proof stress  $\sigma_{0.2}$ : 280 MPa, tensile strength  $\sigma_B$ : 383.7 MPa, elongation  $\varphi$ : 12-18%.

**Fig.1.** Microstructure of the alloy in rolling direction

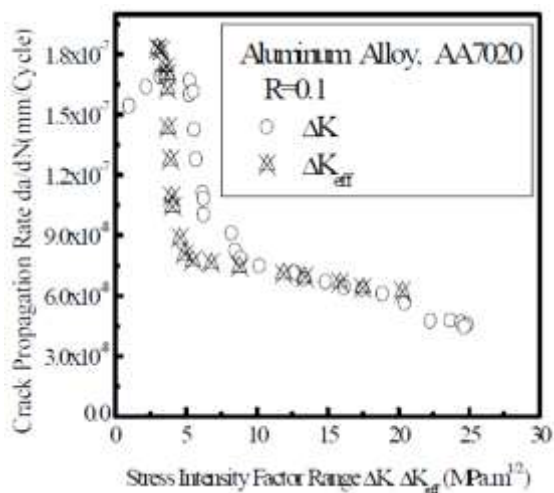
The relationships between crack propagation rate,  $da/dN$ , and  $\Delta K$  and effective stress intensity factor range,  $\Delta K_{\text{eff}}$ , for large cracks are represented in Figure 2. A great amount of work has been done in determining the fatigue-crack propagation characteristics of aluminum alloy [ASTM Spec. Tech Publ. *et al*, 1967; Proc. Crack Propagation Symp *et al*,

1961]. It is worth noting that the  $da/dN = \Delta K$  relationship consists of two sections with different slopes below and above  $\Delta K = 5.5-8.5 \text{ MPa}\sqrt{\text{m}}$ . This tendency becomes much more remarkable when crack closure is taken into account, i.e. FCP rates are characterized in terms of  $\Delta K_{\text{eff}}$ , where the slope change occurs at  $\Delta K_{\text{eff}} = 3.5-6.0 \text{ MPa}\sqrt{\text{m}}$ . Similar slope changes in FCP characteristics have also been reported in aluminium alloy (Jono M, *et al*, 1984) may be related to the transition from structure-sensitive behaviour.

Fig. 2. Relationship between FCP rate and stress intensity factor range for large cracks

Based on fracture surface analysis, it was confirmed that the transition of the operative micromechanisms of fracture has occurred. The transition of fracture mechanism is believed to occur when the cyclic plastic zone size is equal to the average grain size. The cyclic plastic zone size (Tokaji K. *et al*, 2004),  $r_{\text{cp,eff}}$ , for plane strain state is given by the following equation.

Substituting  $\Delta K_{\text{eff}} = 3:5 \text{ MPa}\sqrt{\text{m}}$  and  $\sigma_y = 280 \text{ MPa}$  into Eq. (1), the  $r_{\text{cp,eff}}$  value obtained is approximately  $31.17\mu\text{m}$  which is not in agreement with the average grain size of  $50-80 \mu\text{m}$ . It is interesting to compare the FCP characteristic of the present Al-Mg-Zn-Zr alloy with that of other light metals, i.e. two types of aluminium alloys, 7075-T6 (Tokaji K, *et al*, 1990) and 6063-T5 (Tokaji K. *et al*, 2002).

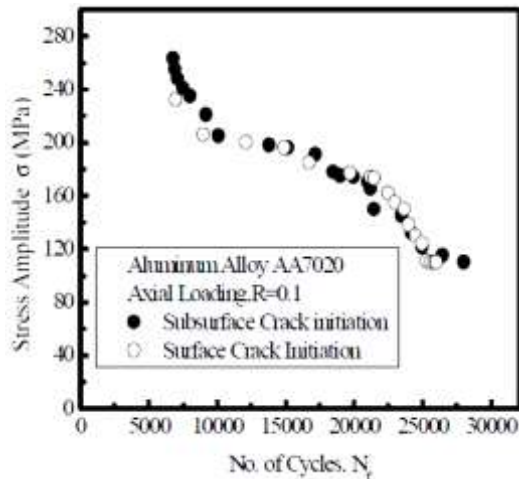
The S-N diagram is shown in Figure 3. It is well known that fatigue limit does not exist in non-ferrous alloys, thus fatigue tests were continued until  $2.85 \times 10^4$  cycles. At  $\sigma = 110 \text{ MPa}$ , fatigue failure did not occur, but non-propagating cracks were observed on the specimen surface.

Fig. 3. S-N curves for the 7020-T6 at R = 0:1

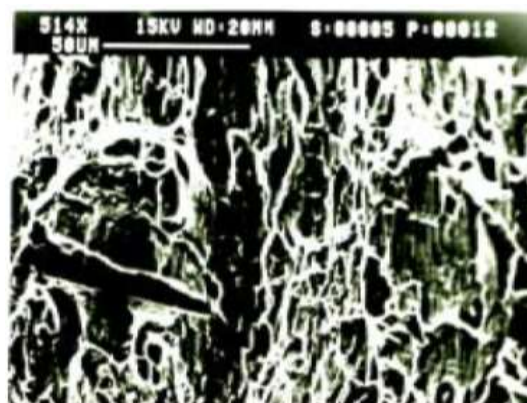
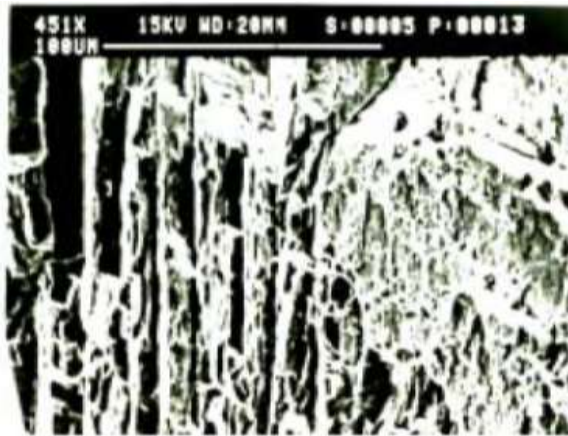
Crack initiation was examined in detail for the main cracks that led to final failure and many other cracks remained on the surface of failed specimens. Consequently, it was found that cracks have initiated within grains (transgranular) or at grain boundaries (intergranular). It can be also seen that initiation in both transgranular and intergranular modes occurred together in nearly (60:40) not equal amounts. Figure 4 reveals typical examples of SEM micrographs showing crack initiation at two magnifications. Figure 4(a) is transgranular mode and intense slip bands can be seen parallel to the severe crack branch, thus the crack generates due to cyclic slip deformation. Figure 4(b) is intergranular mode and intense slip bands are seen on the fracture surface, which have a certain angle against the grain boundary at which the crack initiated. This may indicate that slip bands are major blocked by the grain boundary and thus a stress concentration occurs reasonably, then leading to intergranular crack initiation. The fracture surface exhibits small flat cleaved areas containing small no. of micro-voids. The voids were seen to coalesce to form void lines that are somehow randomly distributed, leading to the development of microscopic and macroscopic cracks both.

**Fig. 4.** SEM micrograph examples of crack initiation at the specimen surface: (a) transgranular ( $\sigma = 200$  MPa); (b) intergranular ( $\sigma = 110$  MPa).
