Fault Tree Model of Collapse Bridge and Risk Analysis of Hassanabad Bridge

Case Study of Hassanabad Bridge Collapsed

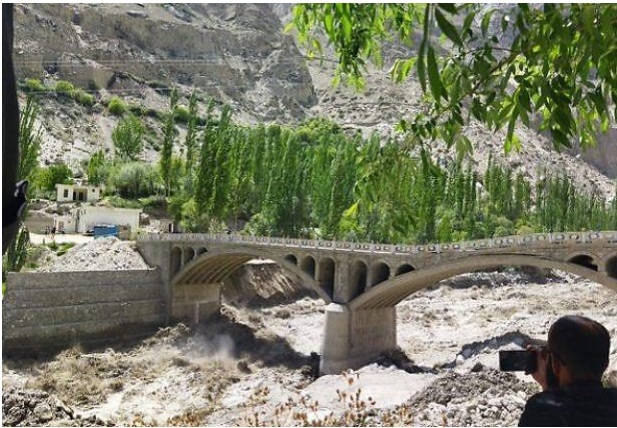
Figure 3 Hassanabad Bridge before Collapse

Figure 3 shows the real picture of the Hassanabad Bridge before the collapse.

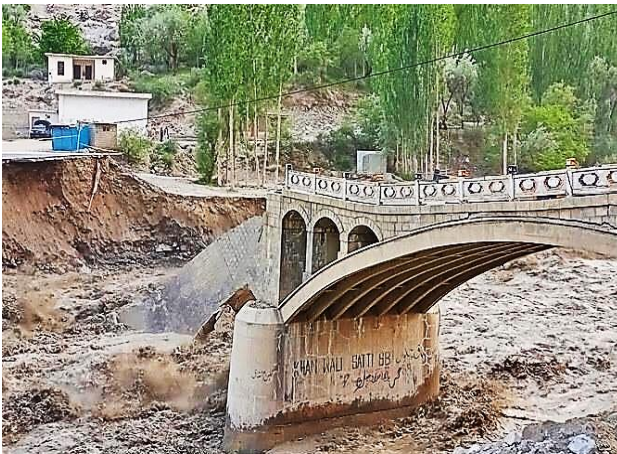
Figure 4 Hassanabad Bridge after Collapse

Figure 4 shows the picture of the Hassanabad Bridge after the collapse.

The management and rescue departments of the local government launched emergency rescue immediately after the collapse. According to the monitoring video, it was determined that the trigger cause of the accident was an arch foot failing at Pier, which caused the collapse of the arch ring in span 2. The collapse of span 2, caused a chain reaction that resulted in the new plastic hinge of the arch ring. Finally, it formed a mechanism that caused the second span to collapse and fall into the water. Fortunately, the first and the piers were rigid, which resisted the unbalanced thrust caused by the collapse of the second spans, and the bridge did not collapse completely.

As can be seen in Fig.4, the channel that is directing the floodwaters to the bridge is not straight. When the floodwater flows and arrives at the flat lands, a relatively wide delta is formed. However, when the Bridge narrowed the width of the delta from about 70 meters to only about 30 meters, presumably to save in the costs of construction. As a result, the floodwaters, instead of flowing unhindered through the delta and being dispersed into the floor of the valley, ended up forced to make a 90-degree turn to the right and flow about 100 meters' parallel to the Interstate Highway 10 and then make another 90-degree turn, this time to the left and pass under relatively short bridge. This turning of flood path without carefully studying the pressures that will be exerted on the embankment and bridge foundations and piers caused the collapse of the bridge.

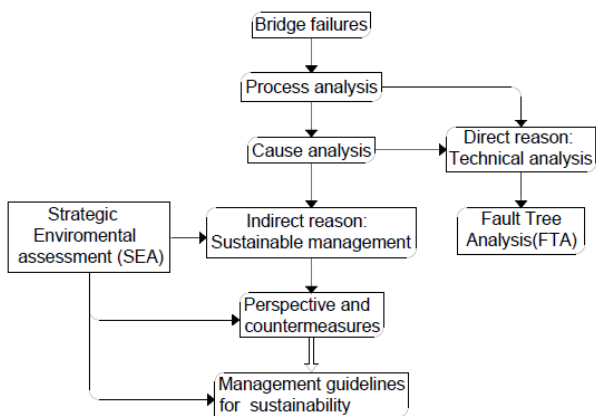
Figure 5 Bridge Failure analysis process

The methodology for the management analysis of bridge failure includes fault tree analysis (FTA) and strategic environmental assessment (SEA). Figure 5 shows a schematic flow chart for bridge failure analysis used in this paper. First, a detailed analysis of the failure process was adapted to analyze the causes of failures. For direct reason analysis, numerical simulation, such as a finite-element method (FEM), was performed to identify the trigger cause and quantitatively verify the bridge failure process. Since this study pays more attention to the managerial reasons based on the technical analyzed results, the detailed technical analysis was used. Management cause as an indirect reason may be more significant than the technical reason, so FTA and SEA were used. Based on technical analysis, FTA was used to show the overall causes of the Hassanabad Bridge collapse and further classify the failure causes qualitatively. SEA was used to assess the management risks of bridge management and provide guidelines for bridge sustainability. SEA analysis was adopted based on six principles for SEA effectiveness to assess the risk probability scores in bridge sustainability. Furthermore, combined with FTA, management analysis using SEA proposed countermeasures and management guidelines for decision-making in development projects, which is pivotal for improving sustainability in terms of society, environment and economy.

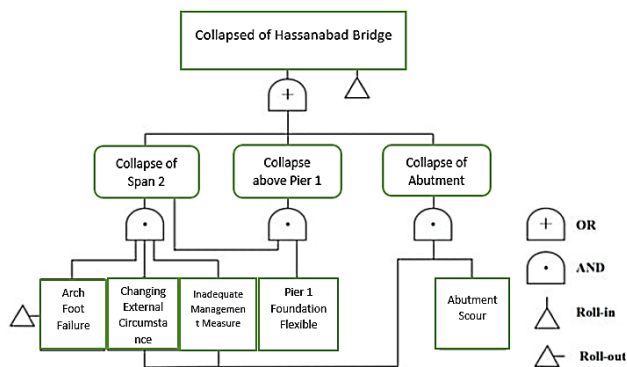
Figure 7 Main Fault Tree Analysis of Hassanabad Bridge Collapse

Based on the FEM results and process analysis, an FTA diagram was simulated. The FTA structure is illustrated in Figure 7. According to the FTA structure, the top event is the collapse of Hassanabad Bridge. The basic events at the bottom consist of the causes of the collapse. The collapse of Span 2 and Pier are intermediate events. All events are connected by “AND” and “OR” symbols logically. Arch foot failure directly resulted in the collapse of Span 2. With the demand of social development, the changing external circumstances such as the constant increasing of the traffic volume value and river flow value increased the traffic load and reduced the bearing capacity. Additionally, inadequate management measures including decision errors and lack of regular inspection had a long-term effect on the bridge structure. Hence, the collapse of Span 2 and the setting of flexible Pier caused the collapse of Span 2. Due to aggravated river scouring and inadequate reinforcement measures, Pier collapsed. It can be illustrated that the arch foot failure is a crucial technical factor leading to the whole collapse of Span 2. In addition to normal events for bridges like river scouring, setting of the flexible pier and ever-changing circumstance, inadequate management measures are potential comprehensive factors causing the collapse. Moreover, when the collapse happened, the bridge had been in service for nearly 50 years, and the load on the bridge deck was small, which confirms that the management of bridge engineering is worth further study.

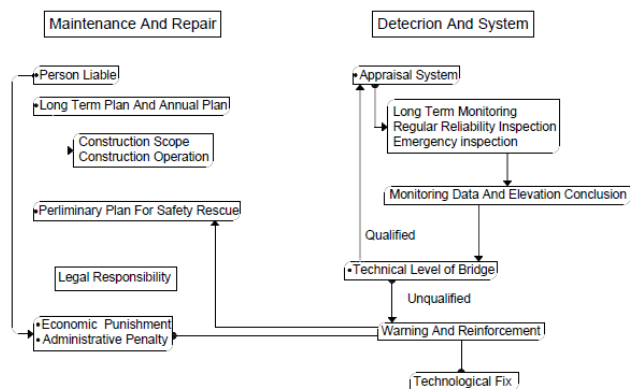
Figure 8 SEA Management measures for the inspection of Hassanabad Bridge

Figure 8 shows the main content diagram of the management measures for the inspection, maintenance and repair Hassanabad Bridges. Comparing articles conducted SEA assessment one by one between the established management measures and the field implementation. Table 1 shows the SEA evaluated results of Hassanabad Bridge based on regulations of the National Highway Authority of Pakistan. The score of SEA is given according to the following categorized management factors: (1) sustainability principles were taken into account in the bridge design phase, but the sustainability principles were been adjusted and improved during operation management and maintenance with the change of environment during bridge service; (2) insufficient monitoring of bridge structural stability during bridge service. The construction scope and operation were not well controlled; (3) despite the promulgation of relevant regulations on sand mining in rivers, the punishment for illegal sand excavation by regulatory authorities is insufficient and sand excavation has a continuous cumulative impact on the environment. The link between administrative law enforcement and criminal justice should be strengthened. (4) The impact of environmental integrity on decision-making and the assessment of the environment is not considered accurately. During flood season, the storage capacity of the reservoir was not considered and the emergency inspection of flood discharge of reservoirs on downstream bridges was not implemented. The construction scope of reservoirs (infrastructures near the bridge was not well controlled; (5) a lack in effective management decision making and measures. The bridge had been put into use before the hidden danger of bridge was solved completely. Hassanabad Bridge underwent major maintenance in November 2019. However, the partial collapse accident occurred at Hassanabad Bridge in 2019. Bridge maintenance was carried out, but the expected results were not achieved.

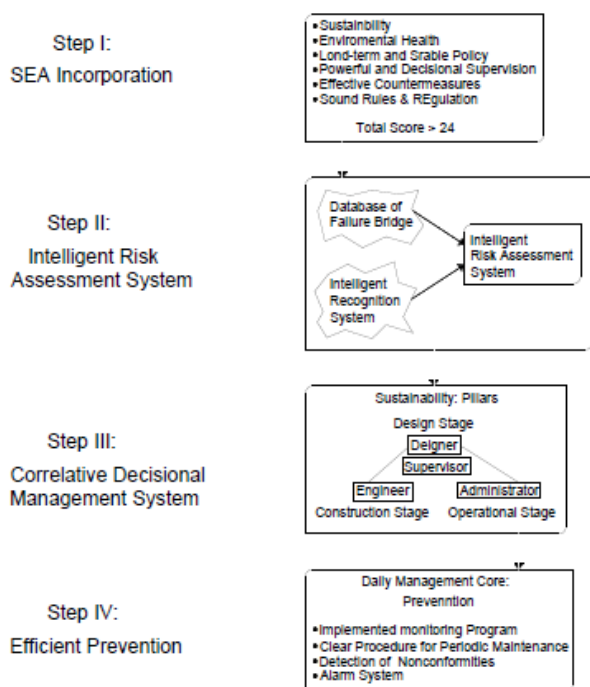
Figure 9 Sustainable Management Guidelines

To improve the management of bridges and other infrastructures, considering social, environmental and economical sustainability, the following management guidelines for bridges and other infrastructures based on the implemented analysis are provided as shown in Figure 9.

Improve the management system with modern and adjusted SEA principles; SEA is recommended to be incorporated into comprehensive project management, the total score of the SEA should be higher than 24;

Establish and update an intelligent risk assessment system [23]. Today's risk assessment performed by

Adopt the correlative decisional management system. The adaptive management system consists of the designer in the design stage, the engineer in the construction stage, the administrator in the operational stage, and the supervisor during the whole period. Each level of management has corresponding responsibilities and should take the three pillars of sustainability into consideration. It is crucial to establish a correlative decisional and cooperation mechanism for the whole management.

Adopt efficient and diversified means of prevention, which are the essence of daily management. The monitoring and clear procedures for periodic maintenance are an important part of preventing failures. In addition, the detection of nonconformities and alarm systems play a major role in emergencies, helping to establish a complete daily management system.
