# Effect of Heat Treatment on Mechanical Properties and Microstructure of ST 37-2 Rear Trailing Arm (Case study at MIE)

Ashish Thakur<sup>1\*</sup> and Gebre-egziabher Aregawi<sup>2</sup>

*This paper presents effect of heat treatment (annealed, quench hardened, and tempered) on mechanical properties and microstructure of the rear trailing arm case study at Mesfin Industrial Engineering PLC, Ethiopia. The samples were heat treated in muffle furnace in Mekelle University, Heat Treatment Lab at different temperature levels and holding times; and then cooled in different media. The mechanical properties (tensile yield strength, ultimate tensile strength, percentage reduction, and percentage elongation), bending, impact and hardness of the treated and untreated samples were determined using standard methods and the microstructure of the samples was examined using metallographic microscope equipped with camera. Results showed that the mechanical properties of ST 37-2 steel can be improved by various heat treatments for a particular application. The micrograph revealed that the microstructure of tempered specimen consisted of a number of appreciable carbide particles precipitated out fr

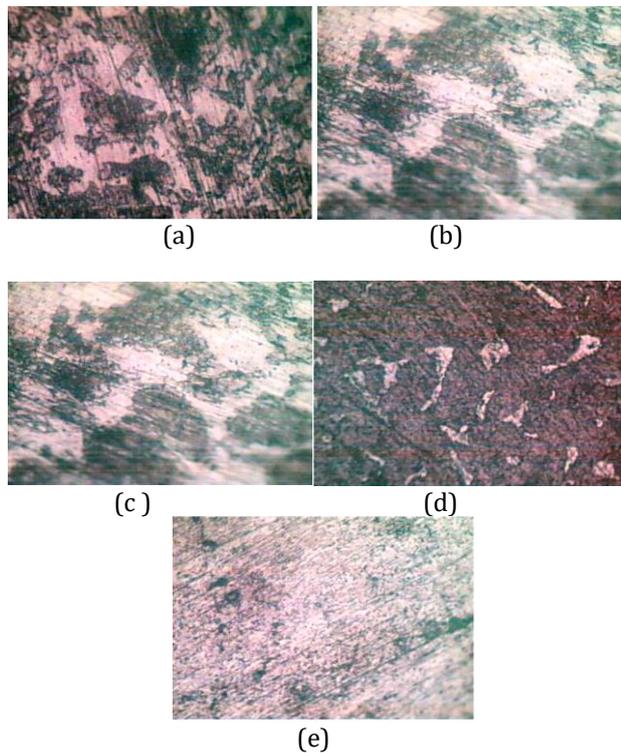
**Fig. 5.** Microstructure observed at 400X for (a) untreated, (b) annealed, (c) normalized (d) hardened, and (e) tempered

The microstructure of untreated specimen given in Fig. 5(a) showed a combination of ferrite (white) and pearlite (black), while the microstructure of the annealed sample is shown in Fig. 5(b). As it can be seen in Figure 5 (b), the ferrite grains had undergone complete recrystallization and these constituted the major portion of the microstructure the annealed medium carbon steel with stress free matrix. At 910°C the deformed structure was fully homogenized and during the slow cooling from austenizing range to room temperature the final microstructure consisted of

fine ferrite grains in which the pearlite was more uniformly distributed. Fig. 5(c) shows the microstructure of the normalized St 37-2 steel [V.B John *et al*; D. A. Fadareet *al*, 2011].

Fig. 5(d) shows the massive martensite structure of hardened sample, when low carbon steels are rapidly quenched from its austenite temperature to room temperature, the austenite will decompose into a mixture of some medium carbon martensite and fewer pearlite as a result of this microstructure which is hard, hence, it was increase in tensile strength, hardness and reduction in ductility of the materials [M.H Jokhioet *al*, 1991; A.K. Charkrabartiet *al*, 1974].

Fig. 5(e) micrograph revealed that the microstructure of tempered specimen consisted of a number of appreciable carbide particles precipitated out from the matrix, which indicated that the precipitate carbide particles decomposed by a process of solution in ferrite matrix.

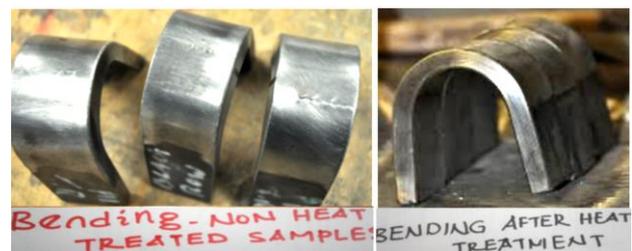
**Fig. 15.** Specimens after bending testing

The results from bending strength testing had been obtained upper and lower results. Bending test results of existing Rear Trailing Arm samples and heat treated samples are shown in Table 6 given below.

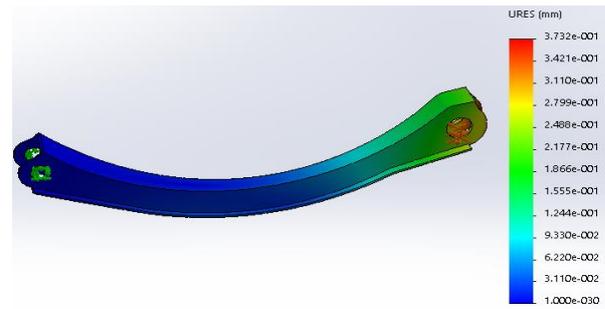
**Fig. 20.** Deformation for the modified design Rear Trailing Arm

The von mises stress observed for 3G load condition of the Rear Trailing Arm is 128.1MPa for St-37, which lies within the yield limit of the material. Von Mises Stress for modified design of Rear Trailing Arm is shown in Fig. 19 given below. Hence the design is safe. Fatigue analysis was also carried out for the tempered modified design of Rear Trailing Arm. Deformation for the modified design Rear Trailing Arm graph is shown in Fig. 20. Damage percentage of Rear Trailing Arm (a) existing (b) heat treated samples is shown in Fig. 21 given below. Static stress analysis result for St-37 Rear Trailing Arm is shown in Table 7.
